Seekoei Estuary Mouth Management Plan March 2018

**Prof Tris H Wooldridge
Prof Janine B Adams
Dr Denise M Schael**

**Institute for Coastal and Marine Research
Nelson Mandela University
PO Box 77000
Summerstrand
Port Elizabeth
6031**

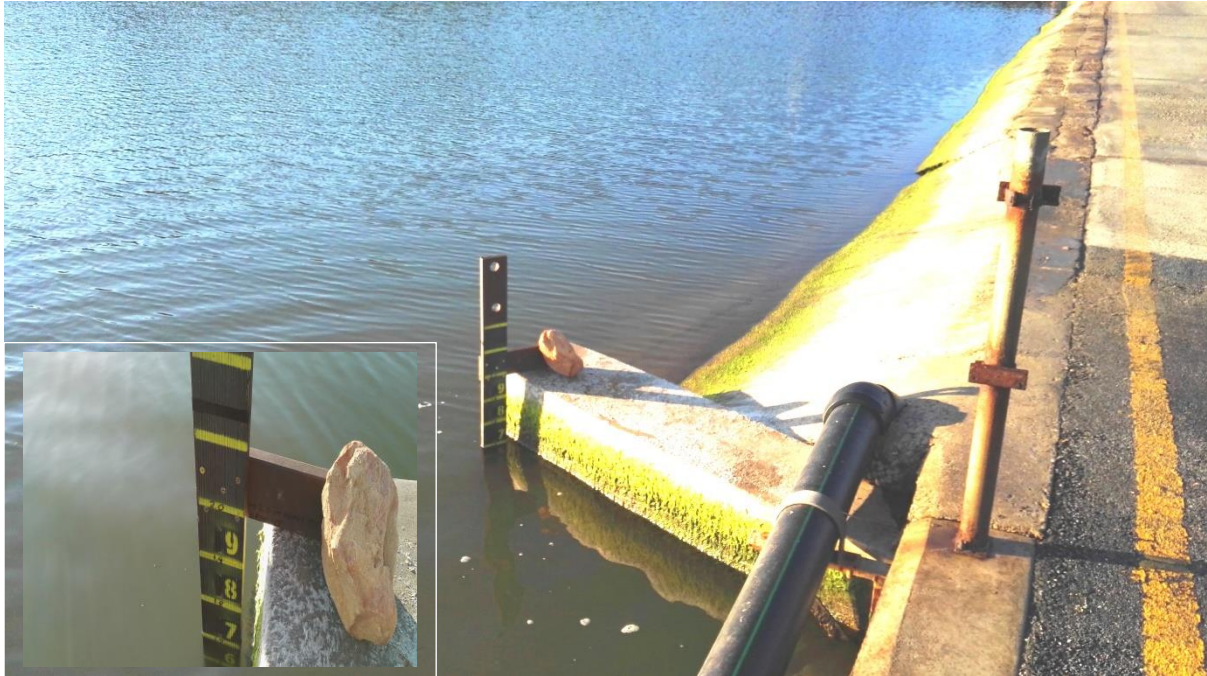
Figure 3 Extended buttress linked to the main culvert under the Seekoei Estuary. The top of the buttress is 100 mm below the roof of the culvert. The temporary gauge in the inset to this photograph shows that the water level is 300 mm below the top of the buttress (Photo: Billy Ives).

The surface of the causeway is not flat and currently, parts of the causeway are lower than the level of the road across the causeway. At such high water levels, the situation can become life-threatening. Considerable damage to vehicles because of the salt water also occurs. Note that the causeway roof is about 100 mm above the top of the concrete buttress (See Figure 3).
